Cracks in Flow liners and their Resolution

I. S. Raju and C. E. Harris¹

Summary

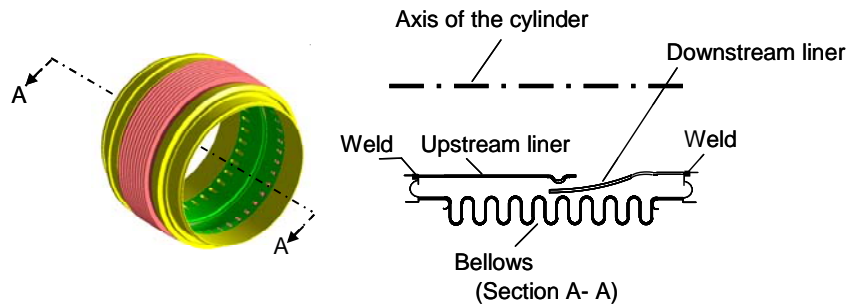
Figure 1: Flow liner configuration (not to scale)

Figure 1 presents a schematic of the bellows region and the flow liners. The upstream liner is a cylindrical shell 0.05 in. in thickness and is approximately 12 in. in diameter. The downstream liner is a doubly curved cylindrical shell of approximately the same dimensions. The flow liners are welded to the feedlines and overhang over each other as shown in Fig. 1. Each flow liner contains 38 slots that are separated by a ligament of 0.75 in. (see Fig. 2). Each slot is about an inch long, with a width of 0.25 in.

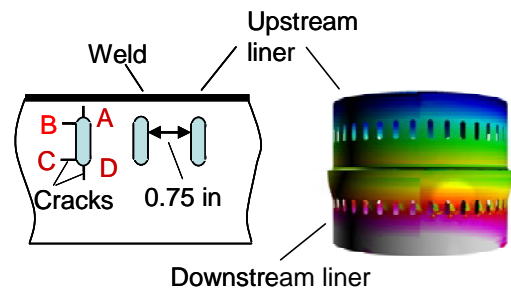
Figure 2: Crack locations at the slots

Figure 2 shows a schematic of the slots in the flow liners and possible crack locations at these slots. Locations A and D are the locations of the axial cracks, and locations B and C are the locations of the circumferential cracks. The welding process results in residual stresses that decrease with the distance from the weld. These stresses were

estimated to be 80, 70, 40, and 35 ksi at A, B, C, and D locations, respectively. The inspections of the flow liners located one axial crack at location A growing toward the assembly weld, 5 axial cracks growing toward the free edge from location D, and five circumferential cracks at location B. Analyses have shown that location B has the highest combination of applied and residual stresses. Therefore, location B was chosen for these analyses. Failure in a liner is defined as crack growth across the ligament to a length of 0.6 in. (The difference in lives for $c=0.6$ in. in comparison to the complete ligament length of 0.75 in. is shown to be negligible [1].) The reason for this failure criterion can be explained as follows. A completely cracked ligament can form a tab, and this tab can break off due to vibratory loads and get ingested into the engine. Such an ingestion can cause catastrophic damage to the engine and the space shuttle.

The 11 cracks found by inspections indicated more crack growth along the outer diameter (OD) than along the inner diameter (ID), suggesting significant bending stresses through the thickness of the liner wall. The manufacturing process created more microscopic damage in the slot surface near the OD. Hence, a reasonable assumption on initial crack shape was a corner crack near the OD edge as shown in Fig. 4. The crack is assumed to grow like a quarter-circular corner crack with $(a/c)=1$ until it reaches 90 percent of the thickness (i.e until $a=0.045$ in.) After that point the crack is assumed to grow parallel to the ID until a crack length $c=0.3$ in. At $c=0.3$ in., the crack is assumed to transition into a through-the-thickness crack. Newman-Raju equations are used for the stress-intensity factors for quarter-circle corner cracks.

detected cracks were removed by careful polishing. The liners were then re-inspected for cracks and returned to service.

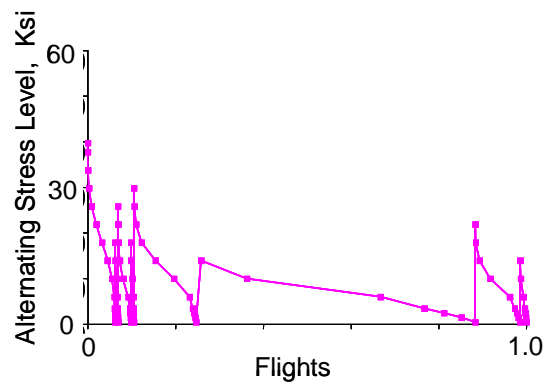
Figure 3: A typical fatigue spectrum

To determine the loads that the flow liners experience, two series of tests were conducted at the NASA Stennis Space center on gimbal joints with flow liners. The flight power levels were simulated in these tests. Extensive strain gage measurements were made and these data were used to infer the loading in the flow liners. In addition, the flow-physics team investigated large scale unsteady motions to the mean flow, back flow, changes in acoustic modes, cavitation, and heat transfer into the flow liner bellows cavity. The loads team, utilizing the results from the flow-physics team and the strain gage data, derived the loading spectra to estimate the load-time history of the liners during flight operations. The team's analyses also identified predominant modes that the liners experience during flight. The predominant mode for the upstream liner is a C9ND mode (C9ND refers to a complex 9-nodal diameter mode, and complex mode suggests both membrane and bending modes act simultaneously), while the downstream liner has 3 predominant modes – 3ND, C4ND, and 5ND. The fatigue loading spectra were determined from these loading spectra and the rainflow method of cycle counting. A typical fatigue spectrum is shown in Fig. 3.
